Jubilee Lake

Union County

Grande Ronde Basin

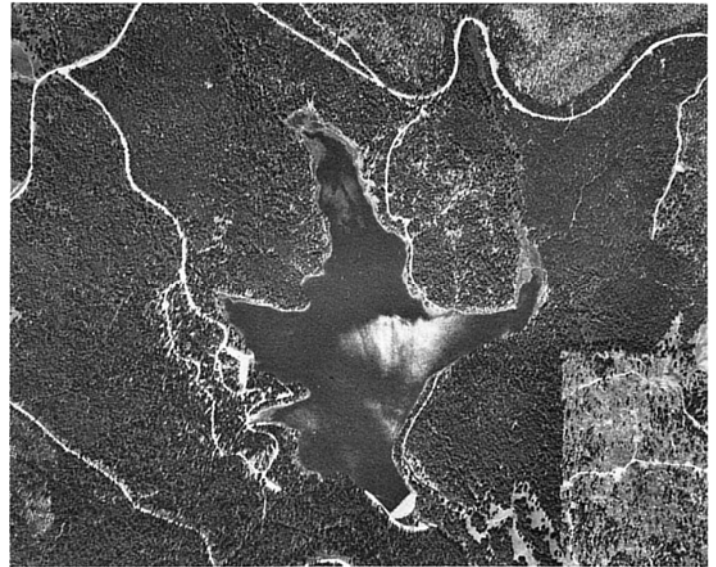
Source: U.S. Forest Service, 1980. Vertical photograph
