Charleton Lake

Deschutes County

Deschutes Basin

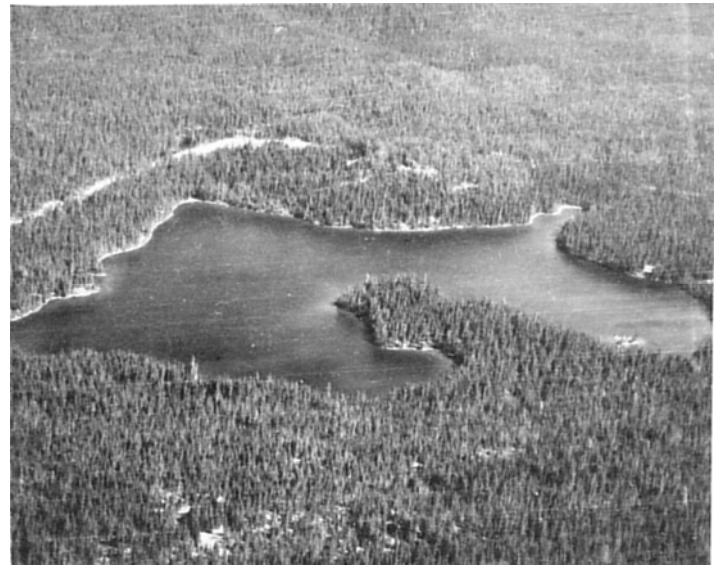
Source: Oregon National Guard, 1981-82. View looking northwest.
