Clear Lake

Douglas County
South Coast Basin

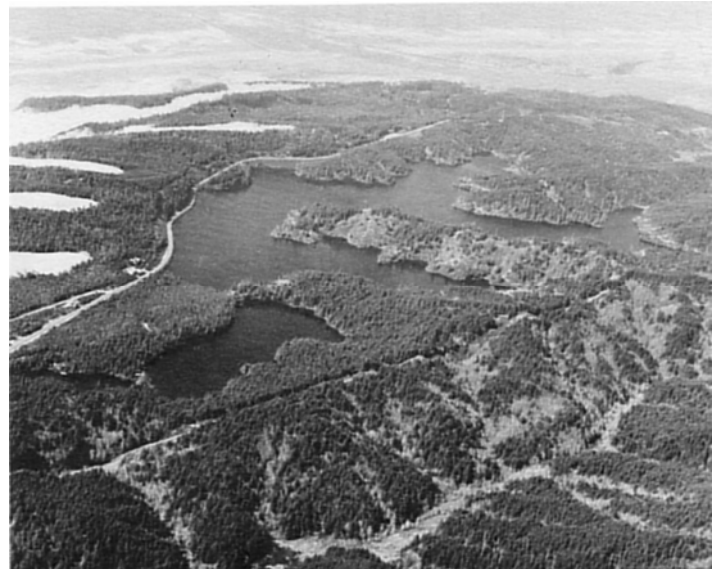
Source: US Geological Survey, 1979. View looking northwest.

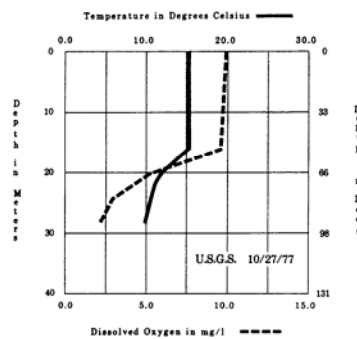
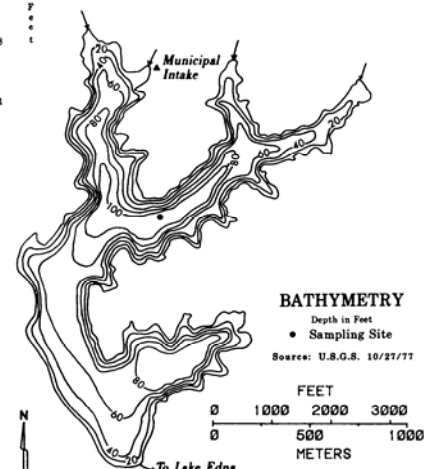
TEMPERATURE AND OXYGEN

A pronounced temperature stratification develops in the summer although the temperature difference between top and bottom is not great. The bottom water (hypolimnion) sometimes becomes partially depleted of oxygen after stratification has occurred, a feature attributed to the inflow of organic material from marshy areas in the drainage basin. Water throughout the lake has a low alkalinity. Phosphorus and chlorophyll concentrations suggest mesotrophic to oligotrophic conditions. Similarly, the species of planktonic algae (e.g. Cyclotella stelligera and Melosira sp.) are found in both mesotrophic and oligotrophic lakes. Given the extremely high water transparency (Secchi disk depth = 23.0 feet; 7.0 meters), Clear Lake is classified as oligotrophic.
