Wallowa Lake

Wallowa County

Grande Ronde Basin

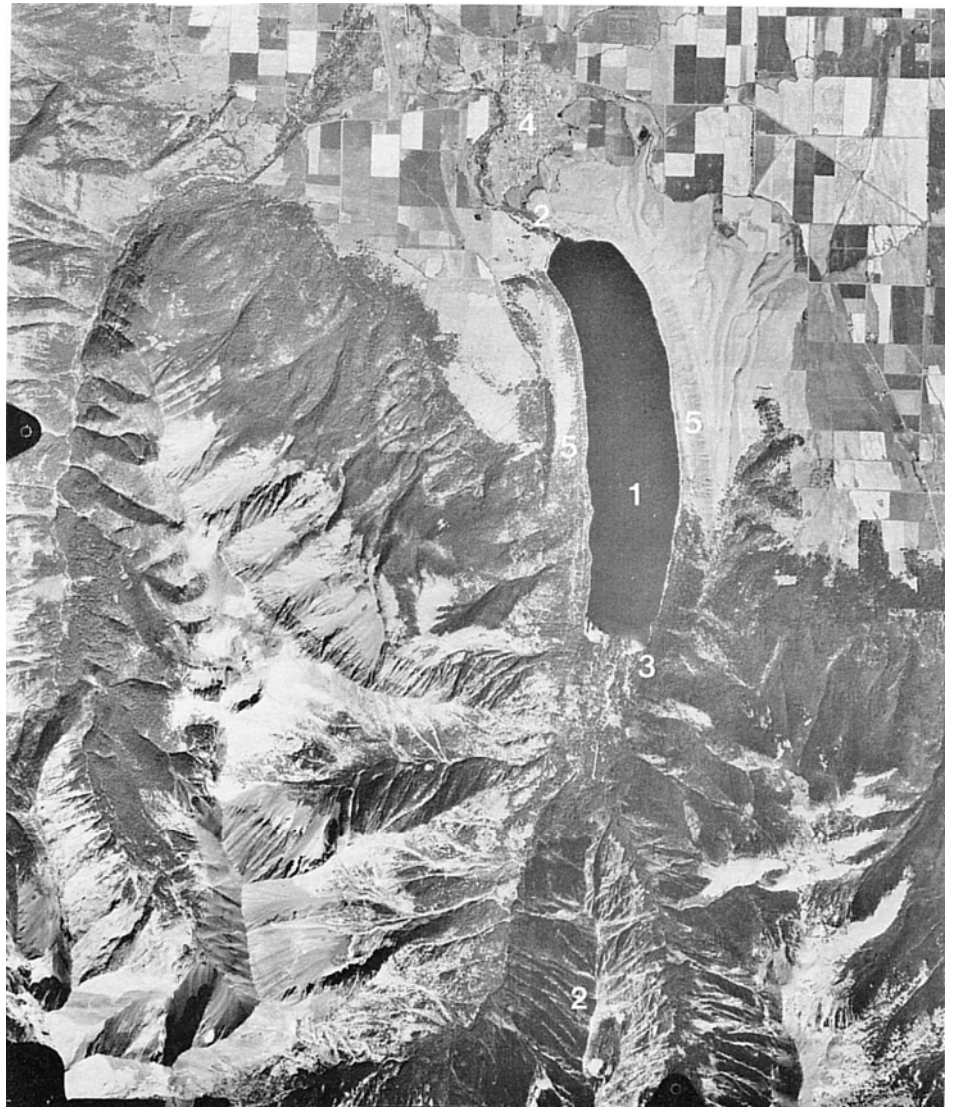
Source: US Forest Service, 1976. Vertical photograph.

Photo captions

1. Wallowa Lake
2. Wallowa River
3. Wallowa Lake State Park
4. Joseph (town)
5. Lateral moraines
